Quiet Warriors and Silent Sentinels

Meeting the Water Infrastructure Challenge in Baltimore

By Cathy Powell

Baltimore Department of Public Works.

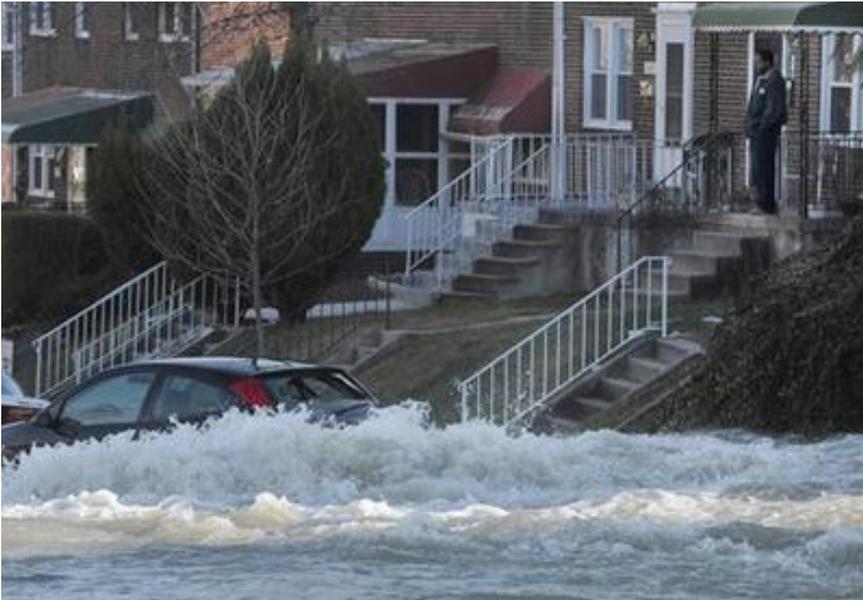
In December 2009, a 42-inch cast-iron main ruptured beneath Argonne Drive in Baltimore.

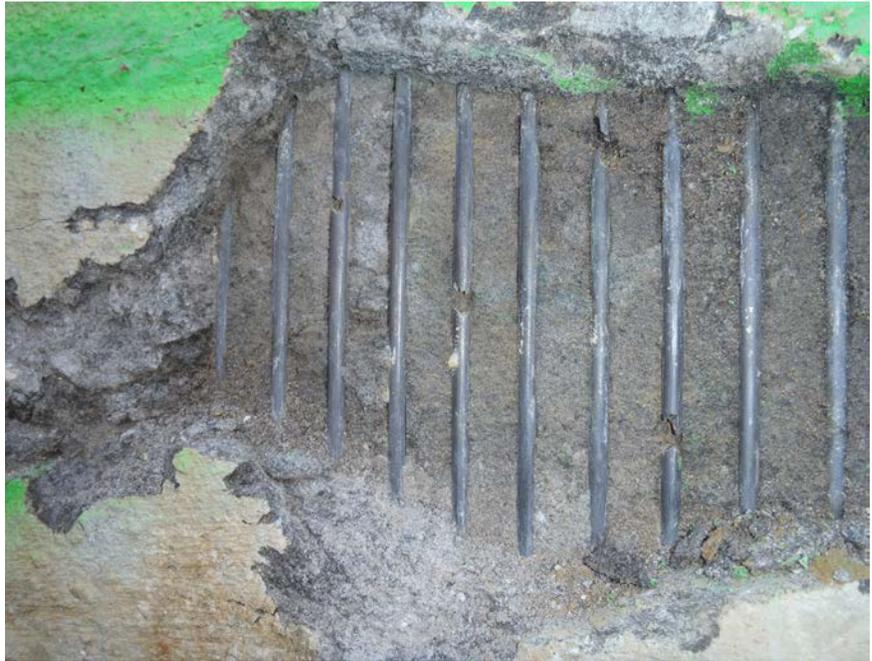
Broken wires on a PCCP main can be seen in this photo.

By July 23, new sections of main were in place and the line recharged. When that section of main was exposed it was instantly clear that the technologies worked. Approximately 30 percent of the pipe section had failed wires; a very dangerous situation on a large, high-pressure main.

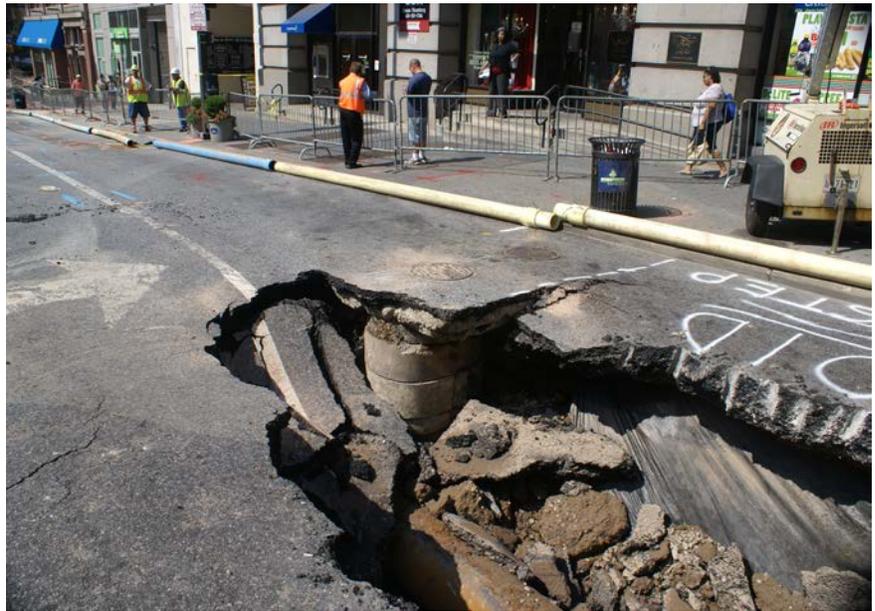
A storm drain failure on Light Street forced the closure of this East Baltimore street in July 2012.

Days later, a 10-foot storm drain tunnel failure in East Baltimore opened a massive hole in the street. Closed-circuit TV and ground-penetrating radar were employed to survey the extent of the damage.
